1955-57 AUTOMATIC STEERING COLUMN SHIFT DETENT FOR TH200, TH350, TH400 AND 700R4

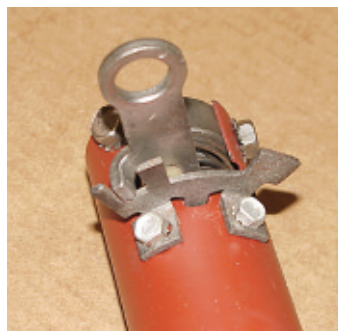
Photo #1: The original automatic steering column utilizes a bolt-on shifter detent at the bottom of the column available as **P/N 19-38** or **19-39**. This detent positively locks the column shift arm in the "Park" position, keeping the transmission safely locked into "Park".

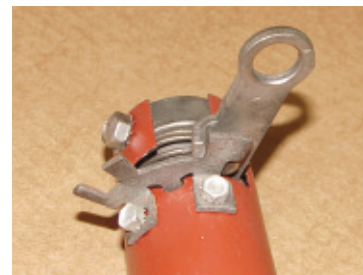
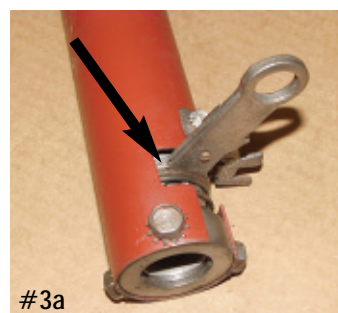
Photo #2: The original shifter detent will only allow the shift arm to travel far enough to operate a Powerglide or Turboglide transmission.

Photo #3a & 3b: There is more than enough room in the notch on the stock steering column mast jacket to allow the shift arm to travel far enough to operate a three or four-speed automatic transmission. If the original detent is modified to achieve the amount of travel needed to shift from overdrive to first gear, the original lower end of the detent will likely break off.

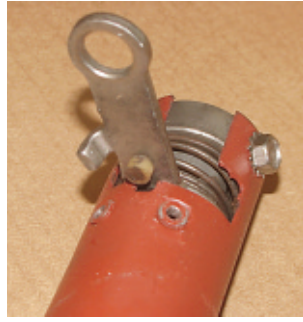
Photo #4: The new shift detent bracket **P/N 53-370** or **53-370P** is made of billet aluminum and includes stainless steel mounting hardware.

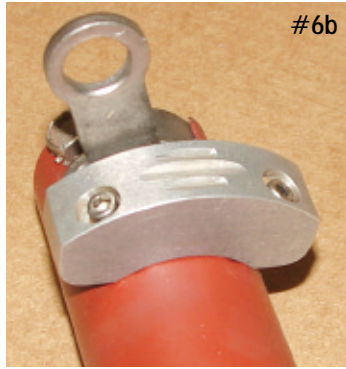
Photo #5: The stock column shift arm has a nylon button that makes contact with the original shift detent when moving through the gears. This nylon button will not be used with the new billet shift detent bracket and should be removed.

Photo #6a & 6b: The original shift detent bracket is held to the steering column with two 3/8" head bolts. The new shift detent bracket is held to the steering column with two stainless steel Allen head bolts.
